Technical Report

IMPROVED RECOVERY VEHICLE (IRV)

M88A1E1 HYDRAULIC SYSTEM ANALYSIS

September 1991

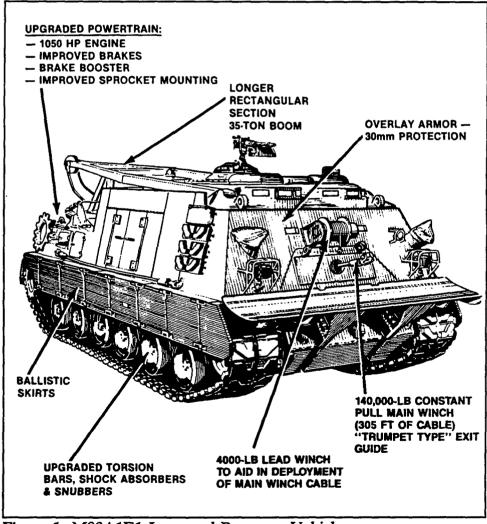
Figure 1- M88A1E1 Improved Recovery Vehicle

The M88A1E1 (Figure 1), manufactured by BMY Combat Systems, is a medium recovery vehicle intended to replace the M88A1 in the recovery of heavy combat vehicles, to include the M1 series of tanks and future heavy combat vehicles. The M88A1E1, which is a product improved M88A1, has an upgraded powertrain, improved winch, hoist, and tow capabilities, and increased armor protection. It also has an upgraded suspension system and an auxiliary power unit for ancillary tools.

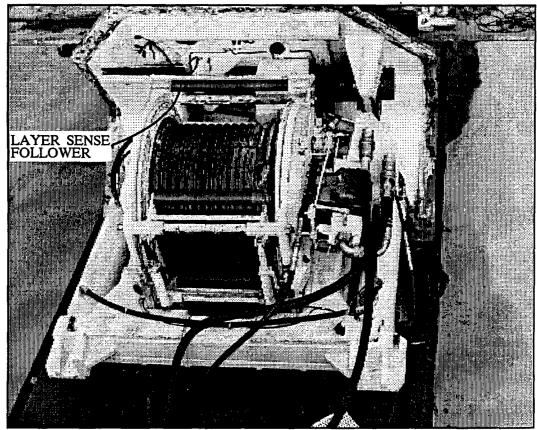
Figure 5 - Layer Sense Mechanism

When cable is wrapped from one layer to the next, increased torque must be supplied. To achieve this, the main winch housing has mounted to it a cable layer sense mechanism comprised of a series of pressure control valves and drum roller follower (Figure 5). As the cable spools onto the main winch (inhauling), the layer sense roller determines the present cable layer and adjusts winch torque accordingly. Layer determination is accomplished through a load sense operation. Load sense ports are marked with an "X" (X-port) and located on the layer sense valve and winch motor. The X-port on the winch reads zero psi for the bare drum (first layer). No volume compensation is needed, since minimum torque is required. As the second layer begins to wrap, the torque requirement increases. Since the same system pressure is acting over a larger momentum, increased torque is achieved by increasing motor displacement. In this case, the X-port pressure increases to 70 psi

which is sensed by the swash plate in the winch motor. The swash plate adjusts to increase its volume output and therefore elevates the motor torque. The winch speed increases from 6.7 feet per minute (fpm) on the bare drum to 7 fpm on the second layer. For the third layer, the X-port pressure increases to 310 psi, and the winch speed increases to 9 fpm.

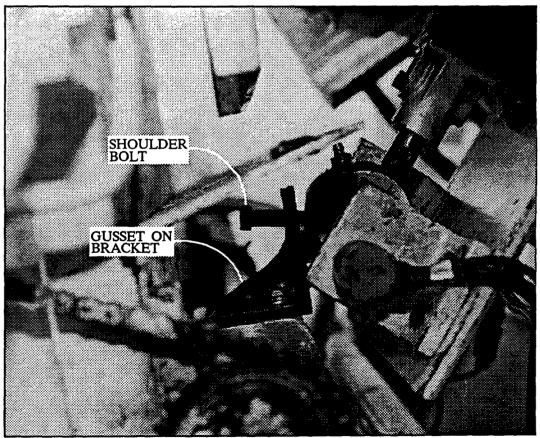
Figure 7 - Strengthened Level Wind Bracket

As noted earlier, stall tests were the first tests conducted; however, they did not proceed without their share of problems. During winch pay out, the level wind mechanism broke twice. To be specific, the follower bracket and shoulder bolt interfacing the level wind cam and diamond screw follower failed. The mechanism was disassembled to analyze the failure. The observation revealed a fractured follower bracket, sheared shoulder bolt, and the probability of flexing in the cam shaft. Bending of the cam shaft may have caused the cam to bind while trying to

move, consequently shearing the bolt and bracket. After the first failure, the bracket was replaced; however, following the second failure, a gusset was added to the bracket to increase rigidity and strength (Figure 7). The shaft which holds the cam was also strengthened (Figure 8). The original shaft was a soft steel with a Rockwell "C" hardness of 13. The new shaft installed was case hardened to a Rockwell "C" of 45. The level wind break was the first major failure of the ST.

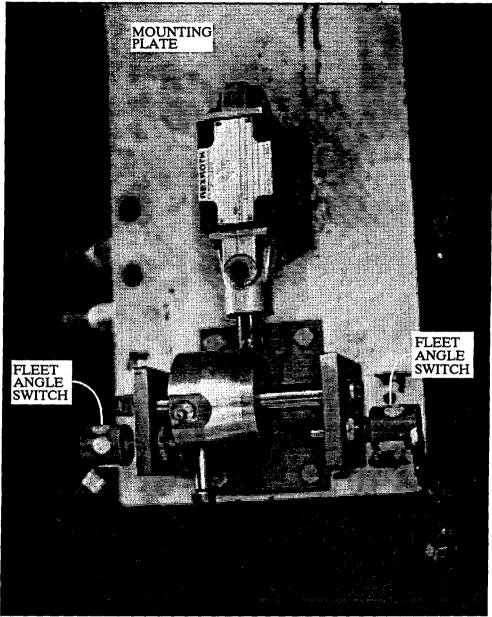
Figure 11 - Fleet Angle Switches

and check for problems. Fleet angle switches (Figure 11) prevent the angle of the cable from exceeding 20° as it is being inhauled. If angles greater than 20° are incurred, then excessive side loading to the trumpet could result in:

- a. Stalling of the level wind cylinder.
- b. Undue stress to level wind cam, diamond screw follower, and bracketry.
- c. Excessive bending stress and abrasion to cable.

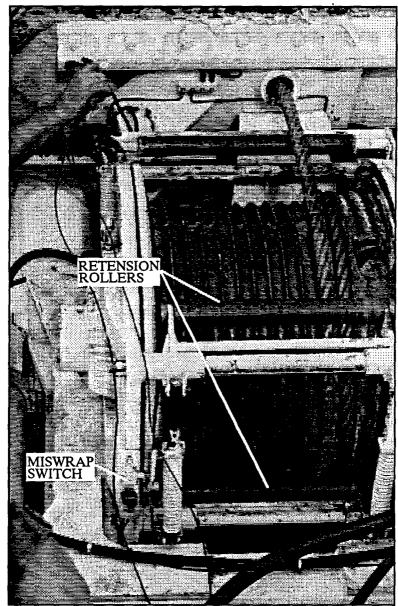
Figure 12 - Miswrap Safety Features

The second safety feature, the cable miswrap switches, warn the operator of possible cable "birds-nesting." Birds-nesting refers to underlying layers of the main winch cable acting as springs and pushing their way up to the top layer and causing a tangle. The cable basically ties itself in knots, which can cause catastrophic failures to the cable, winch housing, and surrounding support structure. To prevent this, a set of cable retention rollers are spring loaded on the back of the winch providing a clamping force against the cable. Attached to the cable retention rollers are the miswrap switches located at the rear bottom of the winch housing (Figure 12). These switches monitor the cable wrapping on the drum. If the cable rises one-quarter inch above the predetermined height, set for three levels of cable, the

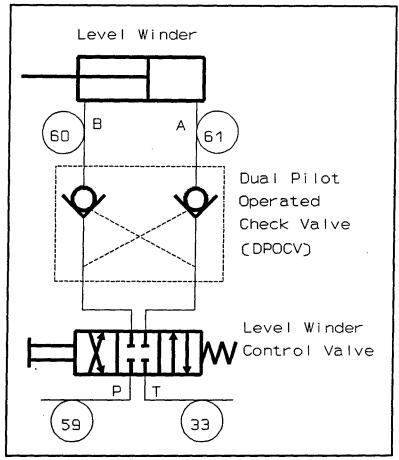
Figure 13 - DPOCV

226°F over the five days of test. On 18 Sept 90 two pulls were made at 90% of full load. During the second 90% pull, smoke was observed coming from the nosepiece trumpet. The pull was stopped to investigate. One of the technicians revealed that the cable had started to wrap on itself but not enough to trip the miswrap safety switch. A closer inspection, again, exposed the shoulder bolt locked to the level wind cam had sheared off. The vehicle was taken back to the maintenance bay to further analyze this repeat failure. Investigation during test indicated that with no hydraulic pressure to the level wind cylinder, the nosepiece trumpet continued to move. It was assumed with the hydraulic pressure is off, the level wind cylinder should hold the winch cable in place; this did not happen. Review of the hydraulic system uncovered the absence of a cylinder lockout in the design. A 90% load

equates to a 126,000-lb force on the cable and during the test the cable was being inhauled at an angle. With the load at an angle, a side load is induced (sine of the inhaul angle) forcing the level wind cylinder to either side. With the cylinder moving and the drum stationary, the bracket and shoulder bolt bridging the two together ultimately shears. The theory was validated by conducting several subtests using a portable hydraulic jack to push the trumpet back and forth with no power to the nosepiece.

Having determined the root of the shoulder bolt failure, a cylinder lockout was designed into the system (Figure 13). The figure depicts the position of the valve as installed into the system. The circled numbers correspond to the designated positions on the BMY hydraulic schematic. Reference Appendix D schematic for location. The lockout consists of a double-pilot-operated check valve (DPOCV) positioned between the level wind cylinder and the cylinder directional control valve (Figure 14). In using a DPOCV, flow out of the cylinder from either end is stopped when no hydraulic pressure is applied. The DPOCV was selected, procured, and installed. BMY was informed of the change, and they indicated that the DPOCV would be incorporated into the M88A1E1 design as drawing "BML 39594." Careful review of past level wind failures indicates that the DPOCV is a viable solution.

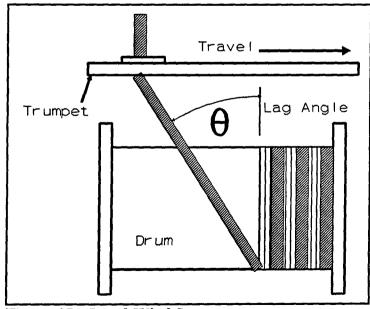
Figure 15 - Level Wind Lag

By 16 Nov 90, the hydraulic alterations were completed, and the ground hop procedure was begun on P4. With the nosepiece out, the cable was paid out one complete wrap. It was noticed that the directional valve cam follower for the level wind was riding in the extreme positions of the cam, causing the cylinder to lag behind (Figure 15). This condition indicated that more flow was being required to

keep the level wind synchronous with the winch drum. Maximum in and out positions of the valve equates to maximum valve opening. Three separate attempts of paying the cable in and out resulted in the level wind lagging, which tripped the fleet angle switches causing the system to shut down. In order to fully open the level wind cylinder directional valve and supply more flow, the cam was moved closer to the directional valve. This change resulted in a full open position for the directional valve. The adjustment was made by loosening the slot mounted fleet angle switch brackets and pushing them forward. As a result of this change, the fleet angle switches did not trip the vehicle alarm, and the lagging problem appeared to be solved.

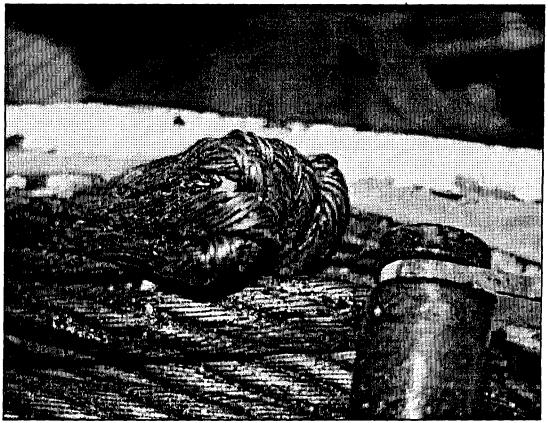
Figure 16 - Birds-Nested and Kinked Cable

On 26 Nov 90, P4 was taken to the ML for the resumption of winch testing. The cable was paid out only five feet, and the warning buzzer in the vehicle went off. It was concluded that the fleet angle switch monitoring the angle of cable inhaul had been tripped. The cable was brought in a foot and then paid out. After another fifteen feet, the alarm again sounded. A visual inspection confirmed that the cable was paying straight out, and the remaining cable appeared to be properly spooled on the drum. All preceding failures to this point of test were caused by the cable being in/outhauled at angles exceeding the limits set for the fleet angle switches. With this background information available, the system override switch was depressed to restart and continue the cable outhaul. With the cable out approximately 50 ft., two loud bangs were heard. The vehicle was immediately shut down, and it was discovered that the cable had birds-nested and kinked (Figure 16). This incident caused a major failure in the main winch housing. A housing tie-rod on the back of the winch was ripped away from the housing (Figure 17). Failure diagnosis revvealed that the cable miswrap warning switches were wired in the same circuit as the level wind fleet angle switches. No indication of excessive cable angle was noted, therefore the alarm was overridden. By overriding the alarm, the cable was outhauled under no tension and birds-nested. A misdiagnosis of the vehicle alarm warning caused the housing failure. The winch could not be fixed due to extensive housing damage; consequently, the entire winch was removed and replaced with the winch from vehicle R2.

Cable birds-nesting continues to be a potential problem for the M88A1E1. Although it was an operator failure, the overriding of the warning signal is a situation that could arise in the field. Should this situation occur, the potential for damage must be minimized. The addition of breakaway bearing caps for the tie rods is a possible solution. Future winch design should consider a fail-safe design for the main winch housing and tie rods.

- d. A fail-safe system should be incorporated in the cable miswrap linkage to prevent main winch housing failure. A "break-away" bearing cap for the housing tierod should be studied as a possible solution.

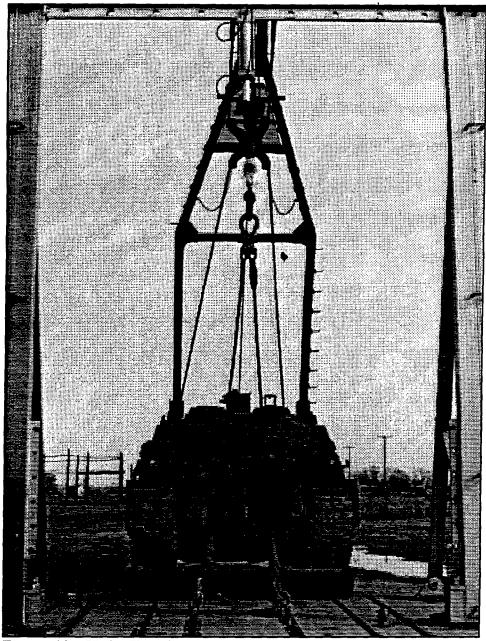
Figure 18 - Hoist Test Setup

Before starting the hoist tests, the vehicle was brought to the lift and tie-down pad to determine the hoist capability, since the system was now operable because of hydraulic plumbing changes. The boom was extended on vehicle P4, and a load cell was attached to the hook block. Spreader cables were then attached to the load cell and shackled to "T" slots in the lift and tie-down pad (Figure 18). The spade

was lowered to provide a mechanical advantage and vehicle support. The hoist was actuated, and a load of 87,000 lbs. was observed. The load was backed off as to not damage the boom, since the force observed was greater than the $70,000 \pm 10\%$ requirement. The hoist winch motor is a fixed volume unit that increases torque through increased pressure; therefore, to limit the hoisting capability, incoming pressure must be reduced. However, if the pressure were to be set for 77,000 lbs. with the hook at the top to meet the requirement, a higher lifting capacity would be realized with the hook all the way out. This greater load may exceed the vehicle's boom specification. BMY was contacted on this matter. They indicated that this

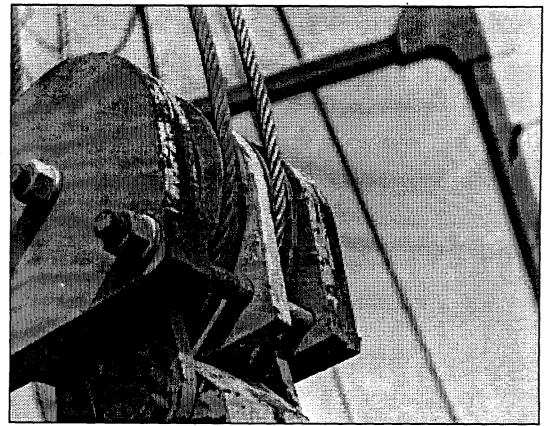
Figure 19 - BMY Hook Block

Once the DCV was set at the proper reduced pressure value, baseline hoisting was started. No overheating of the hydraulic fluid was encountered in the ten lift/lower trials. Problems, however, were noticed with the hook block, as it had to be replaced twice because of excessive wear. The original BMY hook block design (Figure 19) for the M88A1E1 incorporates a bushing for the sheave shaft bearing

surface. The block was not designed for continuous use and consequently encountered failures during test. Continuous use under full load caused extreme heat buildup and wear to the rotating components. BMY has discussed a new

- a. The sheave for the hook block should be changed from a bushing to a roller/ball bearing design for continuous operation. Continuous operation with the bushing design generates heat from sliding friction. Heat buildup breaks down lubrication and causes shaft wear.
- b. The current location of the boom hoist cable deadman allows the cable to twist during operation. The deadman should be relocated to eliminate this twisting action and to keep cables aligned.
- c. Spacing of the boom and hook block sheaves should be equal, as to limit any cable angularity. The fleet angle developed from unequal spacing causes side loading to the sheaves, resulting in bearing and shaft failures.

design with the Johnson Block Company, in which roller/ball bearings replace the bushing.

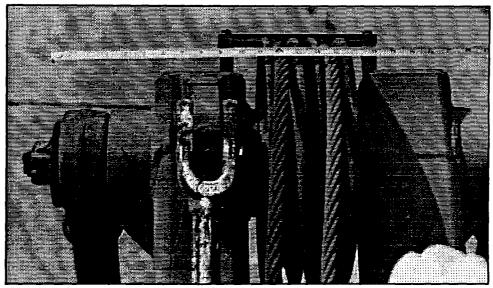
Figure 20 - Boom Sheave and Deadman

The current hoist winch cable deadman location and boom sheave design has also proven to be inadequate (Figure 20). The deadman as positioned on the boom causes the hook block to twist during hoist operation (Figure 21). Twisting of the block causes the boom sheave to bind and cable to wear. In an attempt to minimize twisting, the deadman was rewelded in a new location (Figure 22). Furthermore, binding and cable wear are realized, due to the unequal spacing between boom and hook block sheaves. The angle created during operation induces side loading on the

sheaves. The most noticeable problem occurs during a 70,000 lb. lift. If the hoist was stopped at an intermediate point of travel and restarted, the load would not move due to the frictional buildup.

b. The BMY bushing design for the hoist hook block is underrated for continuous operation. The sheave spacing and deadman location is also inadequate. A redesign of the hoisting hook block and tackle, to prevent cable twisting and wear, is required.

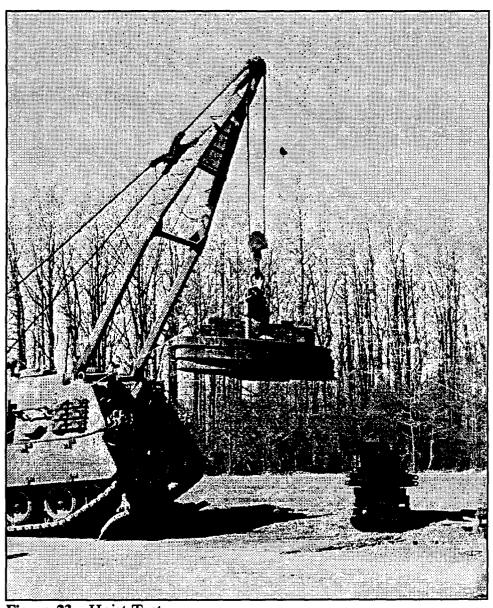
Figure 23 - Hoist Test

As defined in the PD, the duty cycle would entail three full hoists at 70,000 lbs. (Figure 23), and one full winch at 140,000 lbs. (Figure 24) over the first 25 feet of cable and the remainder of the cable length at 69,000 lbs., to be completed in one hour. The aux winch would be used to deploy the main cable. This cycle would be run for four consecutive hours.

Duty cycle tests began 6 Mar 91. At the end of first hour, the reservoir temperature read 155°F. The second hour of the cycle was completed, with the temperature rising to 203°F. At the start of the third hour, the BMY hook block failed on the first hoist, due to side-loading wear and heat buildup. This was the last workable BMY hook block available. All five prototype hook blocks had failed at various times during the ST. BMY did not have any extra blocks or spare parts available for support. In order to continue testing an off-the-shelf commercial hook block was procured in Baltimore, MD. The unit purchased was a Johnson block (Figure 25) rated at 30 tons with a 4.0 safety factor, which equates to a loading capability of 120 tons. The BMY hook block was rated at 35 tons with a 3.5 safety factor for a 122.5 ton capability. The Johnson distributor guaranteed the 30-ton block for a 35-ton application.

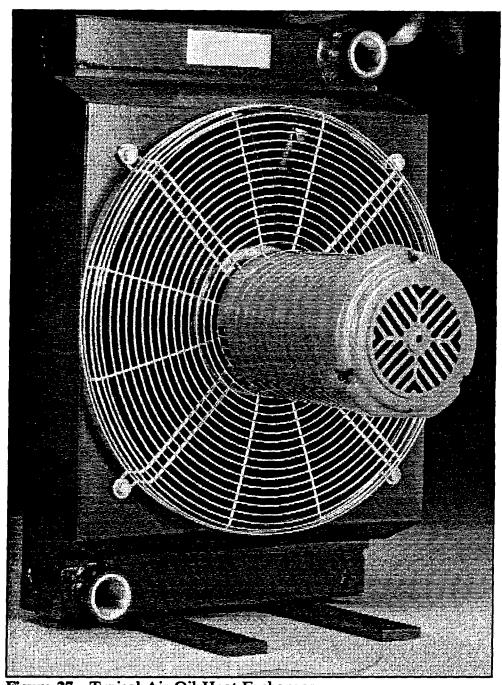
Figure 27 - Typical Air-Oil Heat Exchanger

The only possible solution to complete a duty cycle and maintain a 170°F reservoir temperature is to install an oil cooler. System optimization for piping, valves, and the installation of a three-pump unit will control temperatures for a short time; however, over continuous operation, temperatures will continue to rise until maximums are exceeded. An analysis of the data taken during ST has determined that under maximum heat gain conditions (continuous winch operations at 120°F ambient air temperature), the vehicle will require a cooler sized to reject a minimum of 660 BTUs/min. It should be noted that the ST was performed in temperatures

Upon successfully installing the cooler, a series of tests should be run to optimize the cooler selection. Downsizing of the cooler will be a benefit to vehicle packaging.

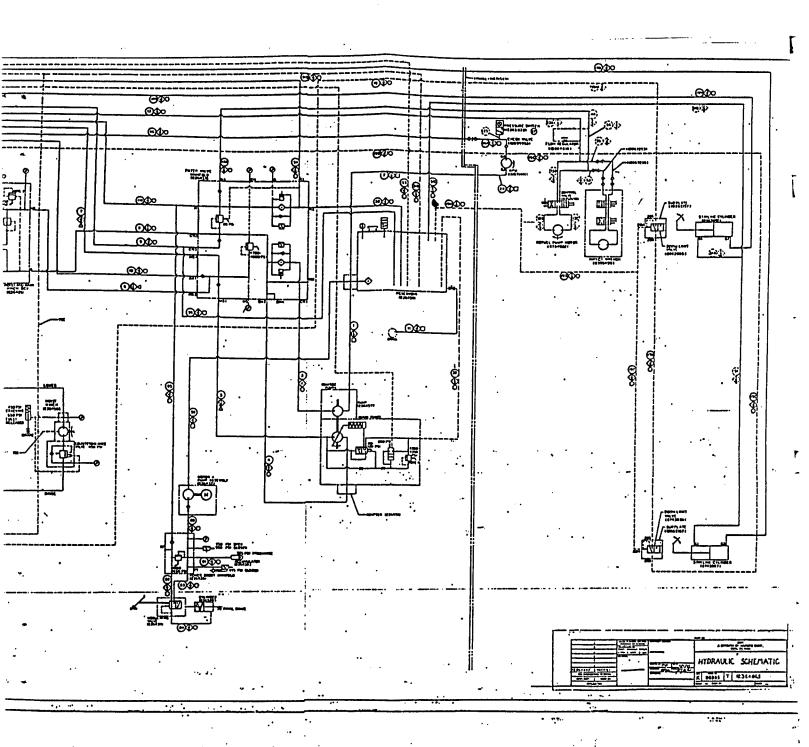
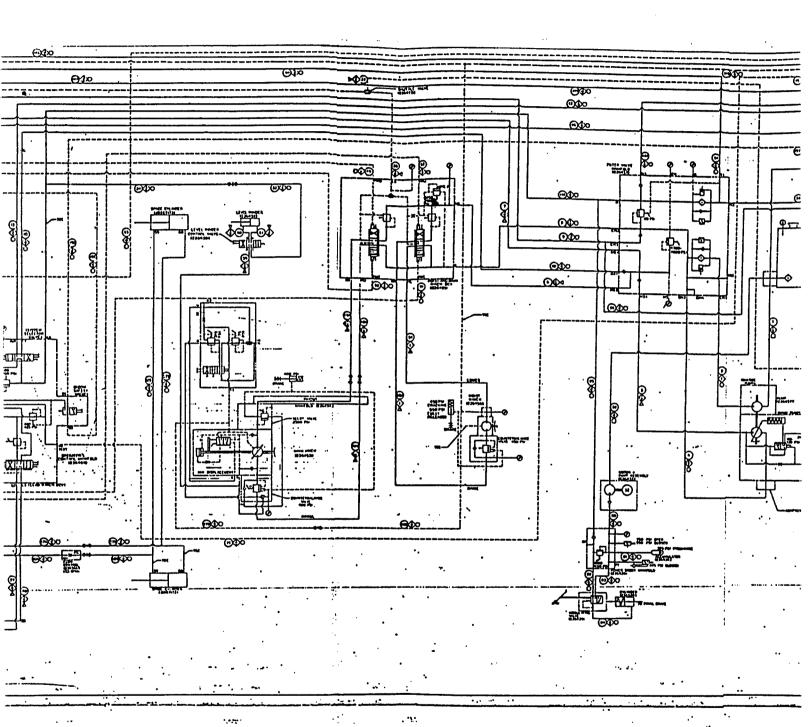
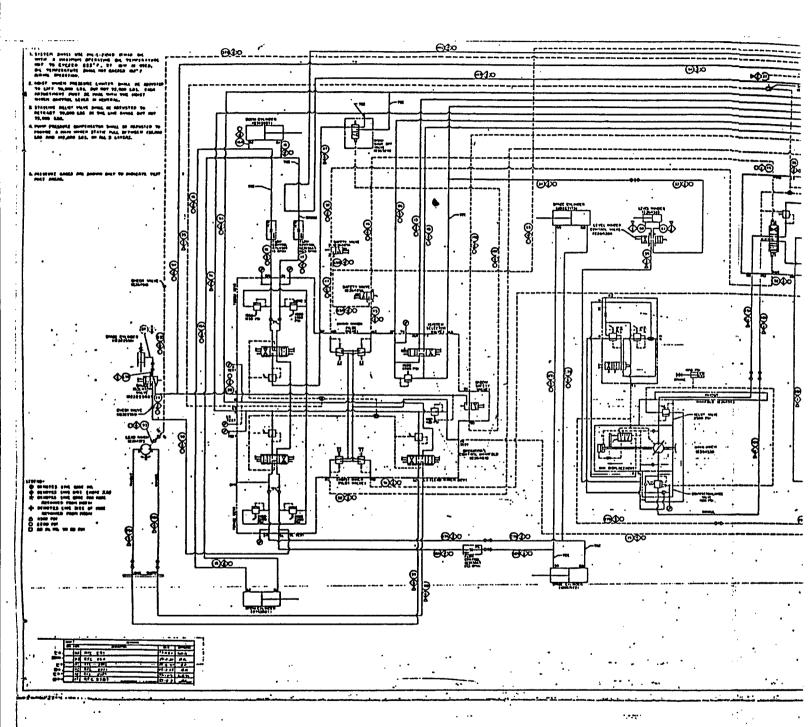
Hydraulic System Diagram

The vehicle hydraulics is designed as a closed-loop hydrostatic drive. Appendix D is a schematic detailing the M88A1E1 hydraulic system. It is a load sense system that detects pressure at the load and sends it back to the pump. Upon being signalled of the actual pressure/loading requirement, the main pump will adjust flow, either up or down, to meet the system requirements. The main system is driven by a variable volume load compensated pump. A charge pump is installed to prime the main pump. The main system pump is the principal unit which drives the hydraulic motors for the main, auxiliary, and hoist winches, and auxiliary power unit. The main system operating pressure is approximately 4,000 pound per square inch (psi), and uses MIL-L-2104D 15W40 oil as the hydraulic fluid.
